National Transportation Safety Board

Safety Recommendation

Date: June 9, 2008

In reply refer to: A-08-25 through -29

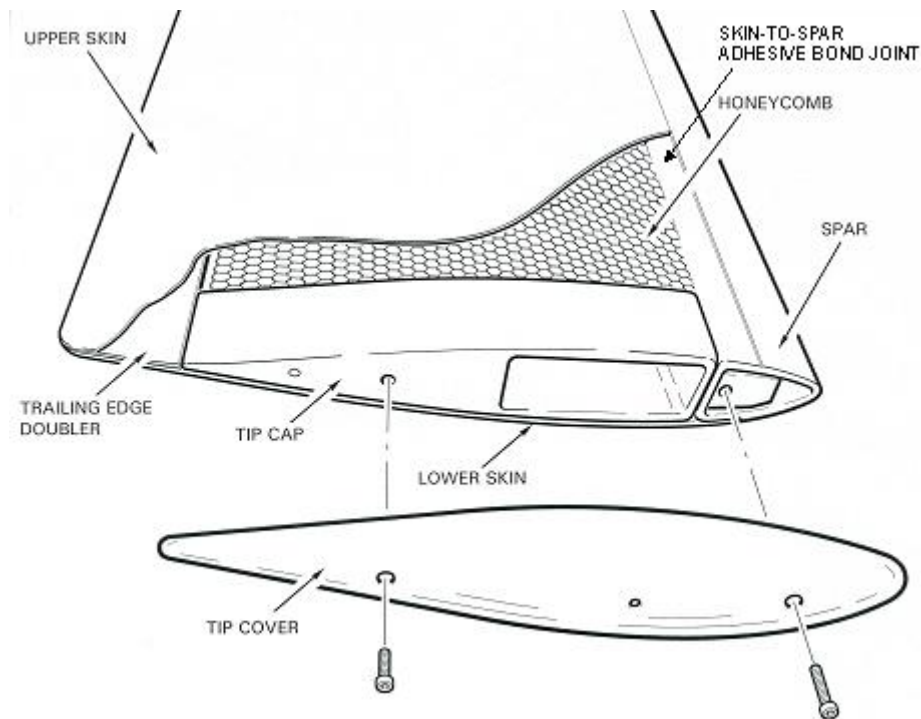
Investigators disassembled the tip cover from the intact main rotor blade and found corrosion and a debond between the lower skin and the spar at the bond joint at the tip of the blade and between the lower skin and the tip cap. The total chordwise length of the debond was about 0.5 inch.

The diagram on page 4 shows a cross-section of the outboard portion of an RHC main rotor blade. The tip portion of the blade shown contains a spar at the leading edge, skin overlying a honeycomb core structure trailing the spar, and a tip cap between the spar and the trailing edge doubler. A portion of the leading edge of the upper and lower skin approximately 0.5 inch wide is bonded to the upper and lower surfaces of the spar on the trailing side of the spar. The pieces on the blade are mostly bonded to each other with adhesive epoxy film, which is cured at elevated temperature, and RHC has not changed the adhesive or bonding process since the blades were introduced. A tip cover is secured to the tip of the blade by two attachment screws. On the

Figure. Cross-section of an RHC main rotor blade at the tip portion.
